# Manhole Inspection Summary

Manhole # S04YY1017MH

Insp Date: **7/5/06 12:30 PM**

**Location** Address: **3712 BANCROFT RD**

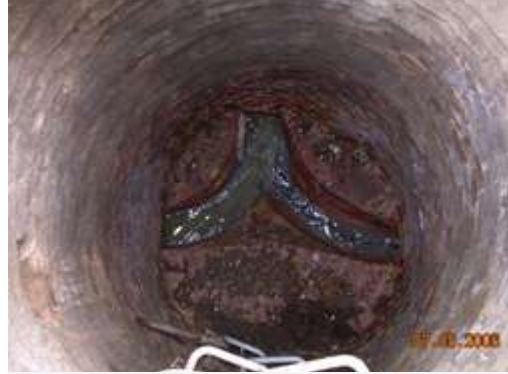
Top View

Adjustment, Corbel and Barrel infiltration.  
Evidence of surcharge- Bench debris.

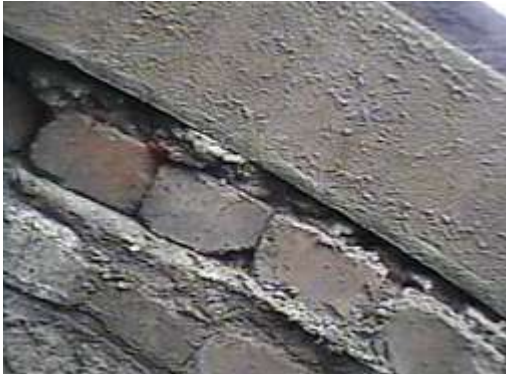
Defect

Frame leaks. Adjustment deterioration,  
loose brick and infiltration.

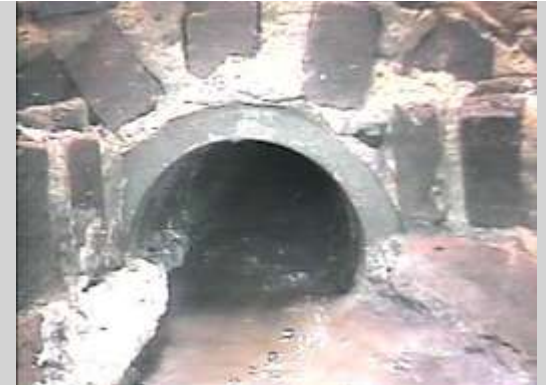
### 8 in. Circular Gravity Sewer Pipe Out @ 12 O'Clock

Comments **The O12 pipe picture shows grease deposits in the Channel and inside of the pipe.**

Deposits: ☐ None ☐ Mud ☐ Sludge ☐ Debris ☒ **Grease**

Silt Depth: **0** (in.) Deposits Extent: **Light**

Infiltration: **Evidence** Pipe Seal Cond: **Unknown**

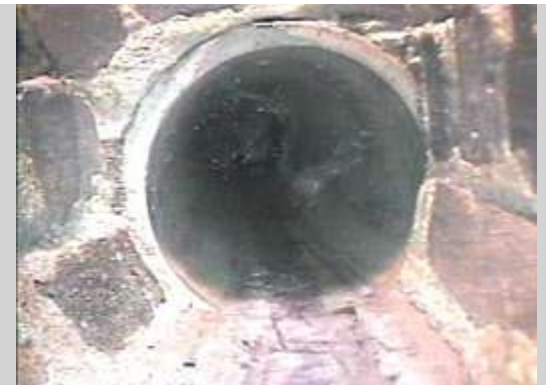
### 8 in. Circular Gravity Sewer Pipe In @ 3 O'Clock

Deposits: ☐ None ☐ Mud ☐ Sludge ☐ Debris ☒ **Grease**

Silt Depth: **0** (in.) Deposits Extent: **Light**

Infiltration: **Evidence** Pipe Seal Cond: **Unknown**

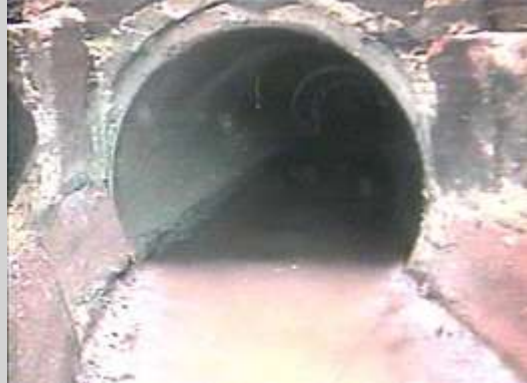
Pipe In @ 9 O'Clock

Deposits: ☐ None ☐ Mud ☐ Sludge ☐ Debris ☒ **Grease**

Deposits Extent: **Light**

Infiltration: **Evidence**

Pipe Seal Cond: **Broken**
